NAVWEPS REPORT 7763
NOTS TP 2739
COPY 87

EVALUATION OF THE EXPERIMENTAL MODEL OF THE RADAR SET GROUP OA-2003(XN-1)/ASB

ABSTRACT. This report discusses the results of the flight testing and evaluation of the experimental model of the Radar Set Group OA-2003(XN-1)/ASB. The characteristics and performance of this equipment are detailed, and certain improvements in design that were suggested for the developmental model are discussed.
(UNCLASSIFIED)

U. S. NAVAL ORDNANCE TEST STATION

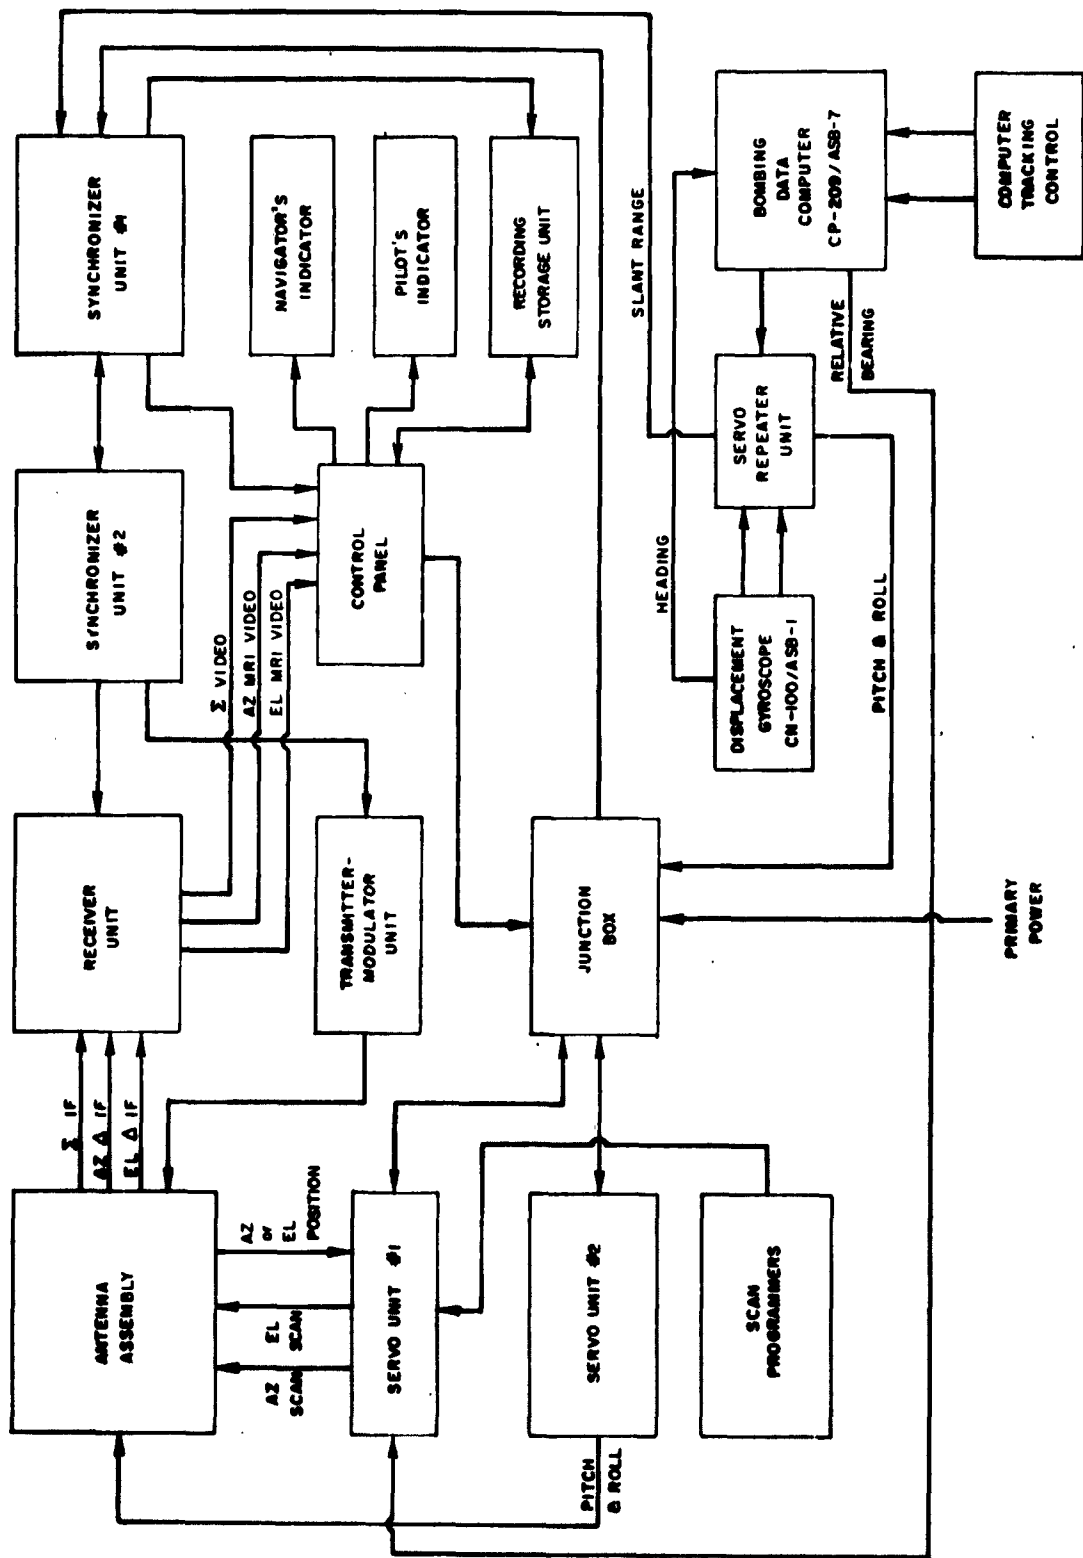
FIG. 4. Radar Set Group OA-2003/ASB Block Diagram

The Radar Set Group OA-2003/ASB (Fig. 1, 2, 3, and 4) is a four-horn monopulse K_u -band radar, tunable over the range of 16 to 17 gigacycles (gc), with a rated peak power output of 60 kilowatts (kw). The four-gimballed antenna is stabilized in roll and pitch to the vertical; in azimuth to the aircraft datum line (ADL), the aircraft drift angle, or the horizontal line of sight (LOS); and in elevation to the angle of attack, the horizontal, or the elevation LOS. The radiated beam is either pencil or fan shaped (cosecant-squared) in the vertical plane, and pencil shaped in the horizontal plane.

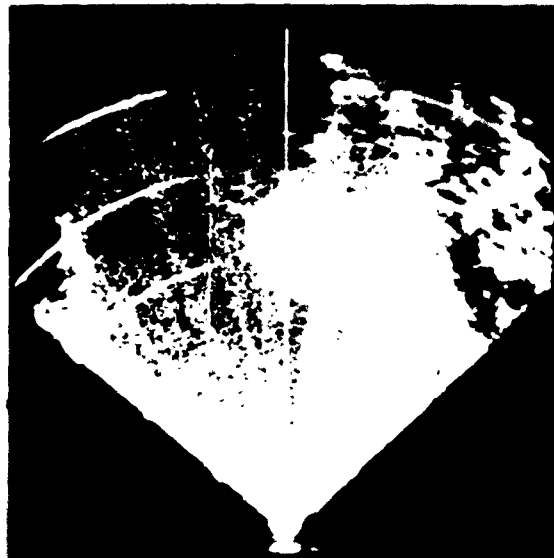
(a) Over La Jolla, looking south to San Diego; 5-mile markers; narrow pulse; pencil beam.

(b) Over La Jolla, looking north; 10-mile markers; wide pulse; fan beam.

FIG. 9. Displays Showing Undesirable Characteristics of Receiver Noise.

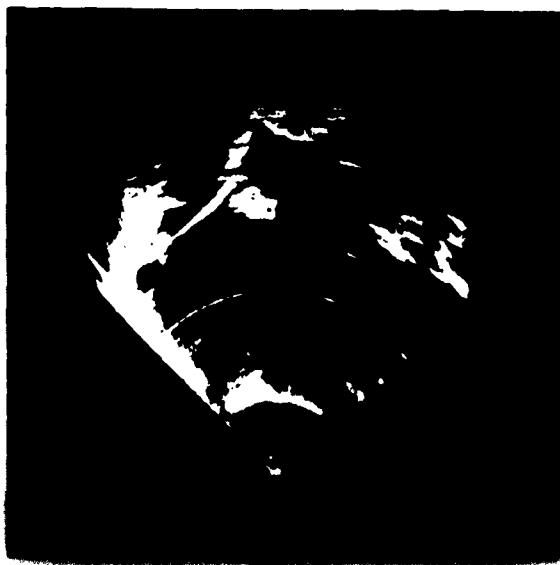
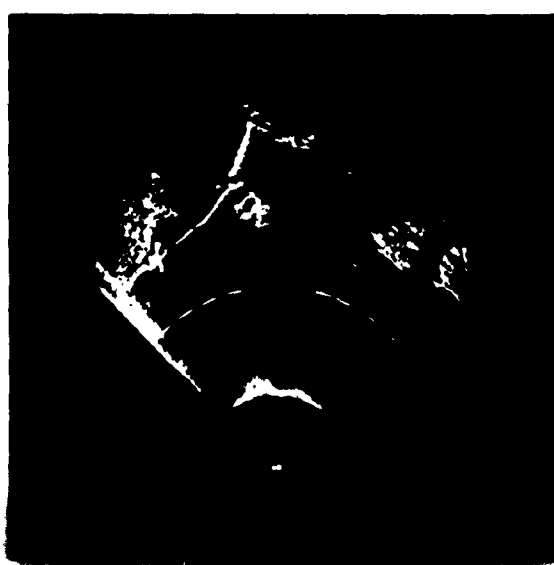
(a) Σ only.

(b) MRI.

FIG. 10. Comparison of Σ Only and MRI Operation, San Francisco Bay Bridge. Note improvement of distortion.

The presentation displayed on the navigator's indicator, conventional cathode-ray tube (CRT), showed a combination of video distortion, 400-cycle noise, inadequate contrast, and initially insufficient gain to permit the display of receiver noise (Fig. 7, 8, 17, 18, and 31). Figure 9 illustrates the undesirable characteristics of noise in the display when sufficient gain was provided and the variation in the noise level with the change in pulse repetition frequency (PRF). The video distortion and the noise problems were largely associated with poor grounds and inadequate shielding of the wiring within the indicator. The noise problem was never completely eliminated, but was improved in time. The inadequate contrast and receiver noise problems were found to have been caused by the video processing circuit where the video, markers, and the unblanking pedestal were mixed, and were attributed to poor direct-current (d.c.) restoration. In time, the contractor provided a newly designed circuit that greatly improved the problem (Fig. 10, 11, 12, 15, 16, 19, and 20).

It was evident from the outset that MRI operation in azimuth was totally inadequate. This was considered the major design deficiency of the radar set. The trouble was pinpointed to the sum (Σ) and difference (Δ) video processing circuits. Throughout the flight-test program, considerable effort was expended by both NOTS and contractor personnel in designing suitable circuitry to achieve the desired results. A circuit design that could adequately improve resolution in azimuth could not be made compatible with the receiver as designed. Figures 10, 11, 12, 15, 16, 23, 24, 25, and 26 show various MRI displays.

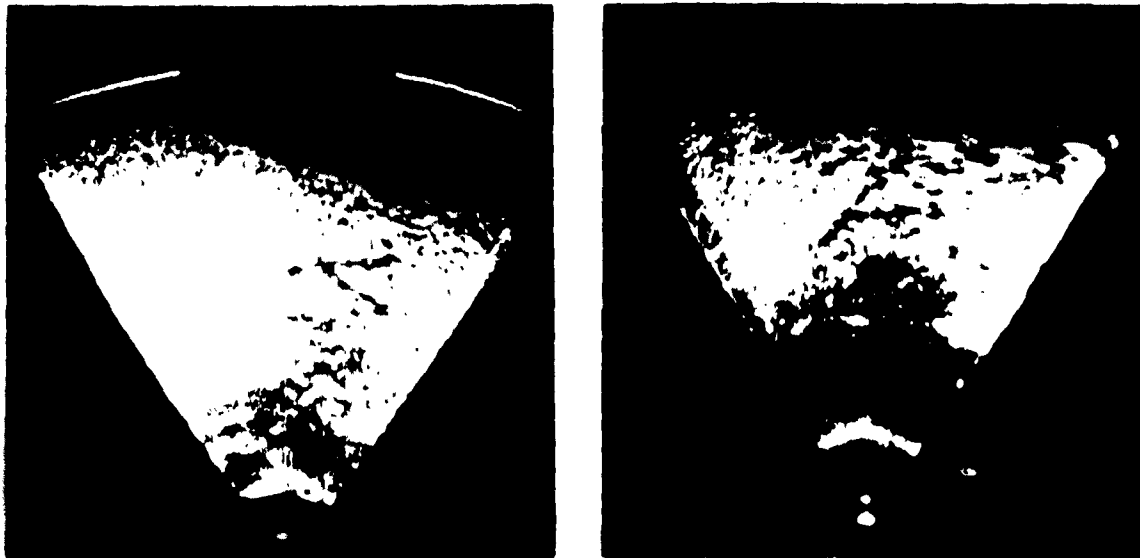
FIG. 11. MRI Displays, Naval Air Facility, China Lake. Narrow pulse; pencil beam; 5-mile markers.

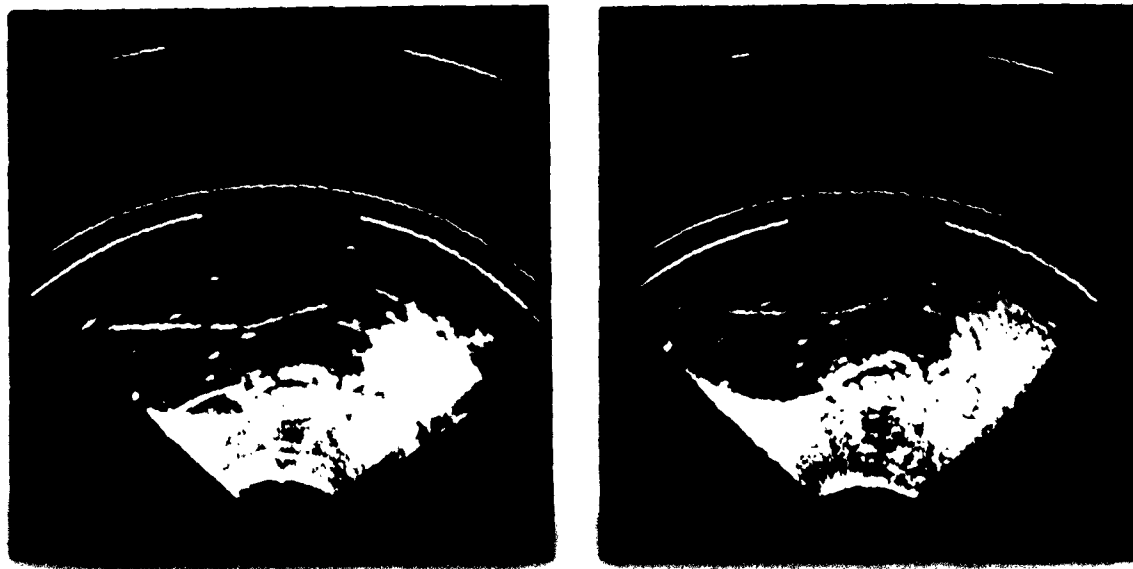
(a) Σ only.

(b) MRI.

FIG. 12. Comparison of Σ Only and MRI Operation, Los Angeles Area (Long Beach). Narrow pulse; fan beam; 5-mile markers.

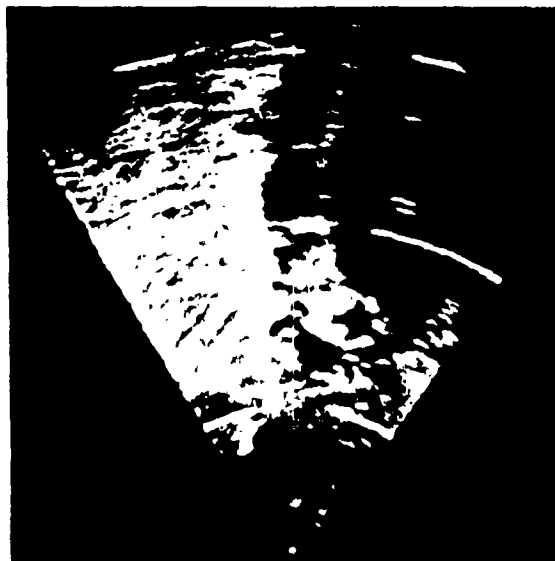
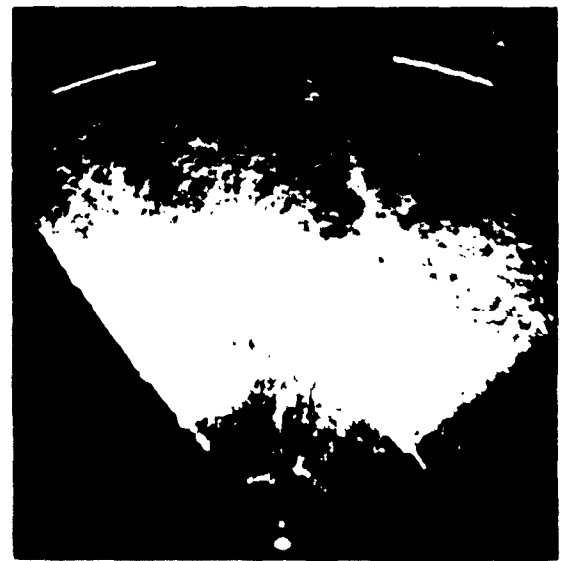
(a) San Diego—North Island area.

(b) Los Angeles area, showing street pattern.

FIG. 19. Displays Showing Improvement of Distortion. Narrow pulse; pencil beam.

Flt. No.	Date	Comments
15	2 May 60	<p>Rerouting, careful grounding, and additional shielding of leads in the navigator's indicator eliminated much of the noise pickup. The aircraft was grounded until 2 May for engine maintenance.</p> <p>This local flight was canceled 25 minutes after takeoff because of engine trouble. The track-while-scan looked good during a short check except for some mechanical overshoot of the antenna during the initial lock-on. Operation of the spoiler seemed sluggish.</p> <p>Maintenance. The spoiler problem was caused by a faulty capacitor in the phase-shifting winding of the spoiler drive motor. A new NAFI-developed MRI circuit was installed.</p> <p>SFO. On this 4-1/2-hour flight to the Bay area, a few terrain-clearance pictures were taken while crossing the Sierra Range, and the MRI looked good in this mode but was unstable. Several pictures of the radar presentations were taken over the Bay area, but the radar was not working well in the Mapping mode. The receiver sensitivity was down and there was considerable waviness on the expanded presentations.</p> <p>Maintenance. Previous trouble with the vacuum switch was remedied by substituting a new coil with increased ampere-turns. The MRI circuit was reworked to give better frequency response. The indicator was again reworked to remove noise pickup.</p> <p>This was an inertial navigation flight of 4-1/2 hours to Gila Bend, Arizona, and return.</p> <p>LAX, SAN. The radar presentation of the Los Angeles area looked very good; this was the first flight on which city streets were discernible in a city complex (Fig. 19).</p>

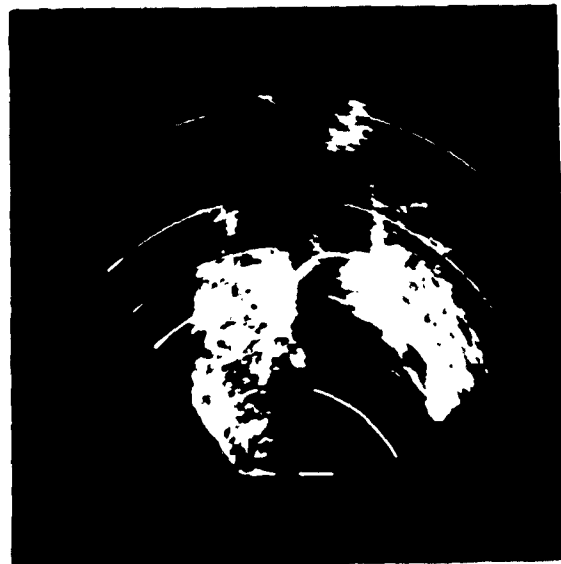
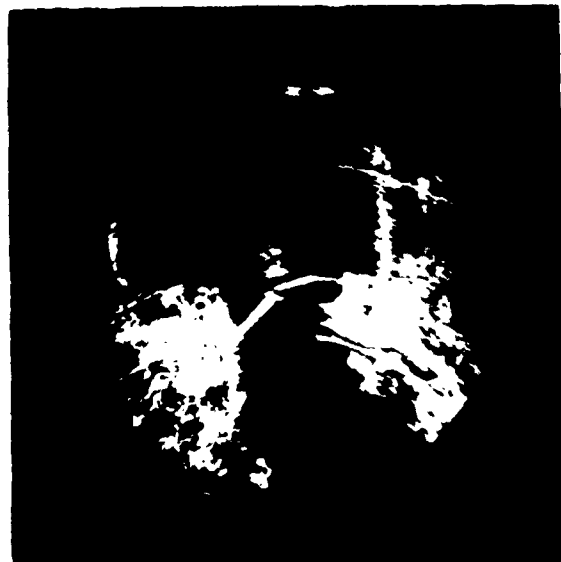
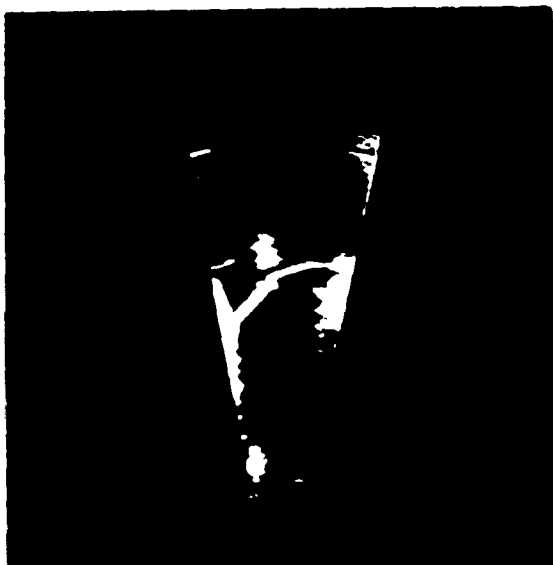
FIG. 20. Bombing—Navigation Mode, Unexpanded Display; San Francisco Bay Bridge and Treasure Island. Narrow pulse; fan beam; ranges are from aircraft to Treasure Island.

FIG. 20 (Contd). Bombing—Navigation Mode, Unexpanded Display; San Francisco Bay Bridge and Treasure Island. Narrow pulse; fan beam; ranges are from aircraft to Treasure Island.

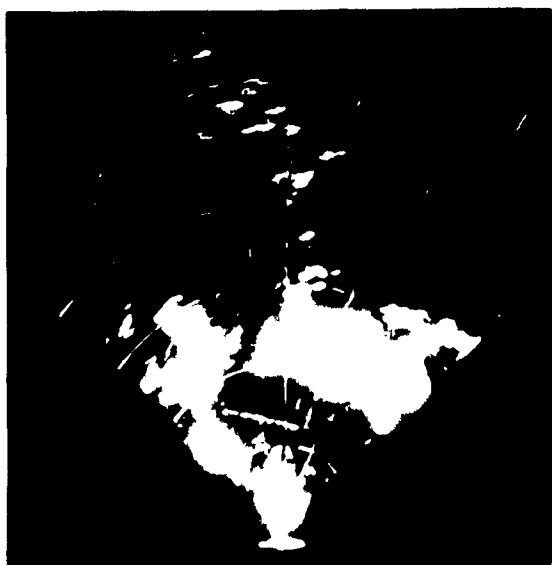
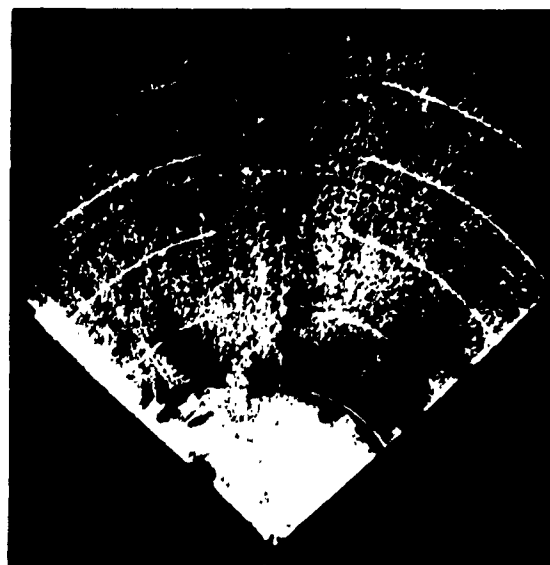
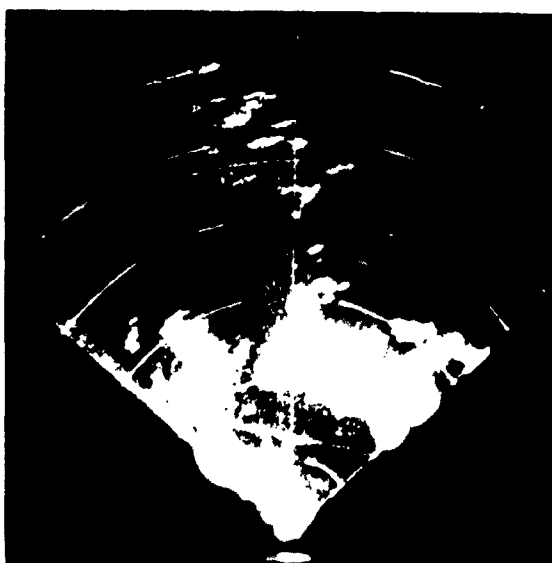
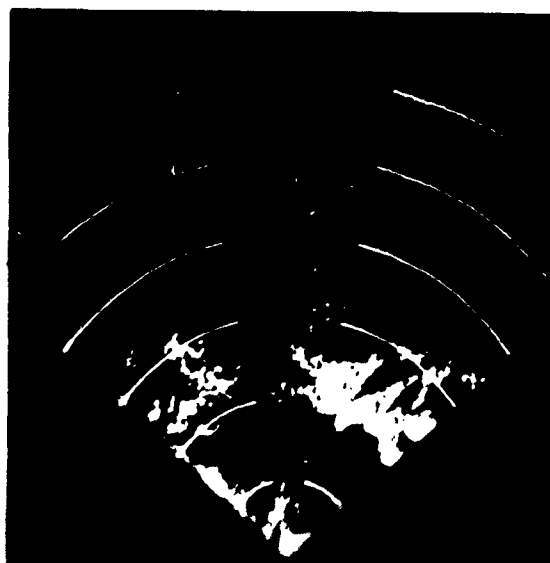
(a) Σ only, maximum gain.

(b) Δ only, maximum gain.

(c) Maximum Σ gain, Δ adjusted for best apparent MRI.

(d) MRI with sacrifice of sensitivity.

FIG. 23. Comparison of Ground-Test Displays Before Changes to MRI Circuitry.

The MRI circuit originally installed in the radar was purely a summing device without provisions for d.c. restoration or adequate clipping, and it caused (1) variations in the baseline level and (2) large amounts of noise from the Δ channel to appear on the navigator's indicator. Several modifications were made to the circuitry, and ground-test results are presented in Fig. 23, 24, 25, and 26.

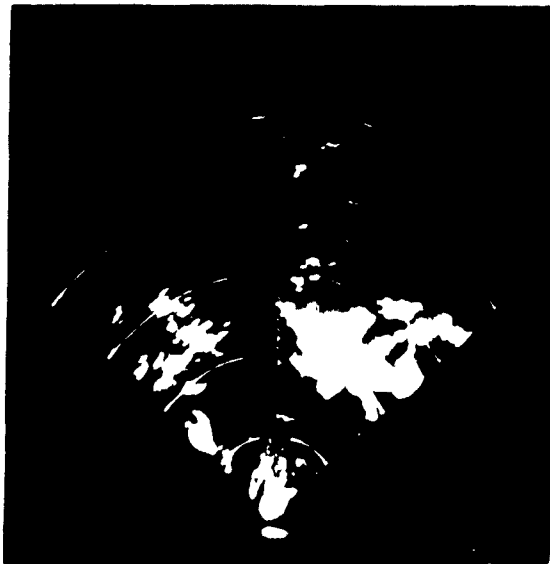
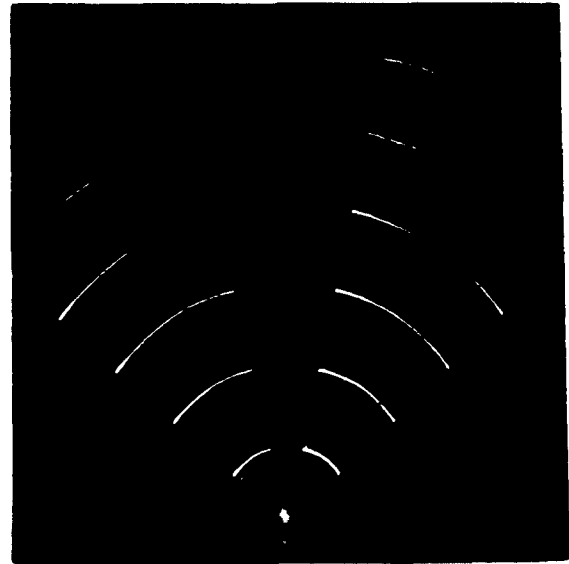
(a) Σ only, maximum gain.

(b) Δ only, maximum gain.

(c) Maximum Σ and maximum Δ .

(d) Maximum Δ , lower Σ gain.

FIG. 24. Comparison of Ground-Test Displays Following Addition of Series Clipper to MRI Circuit. Note elimination of noise in (b) as compared with 23(b); note loss of sensitivity in (c) and (d).

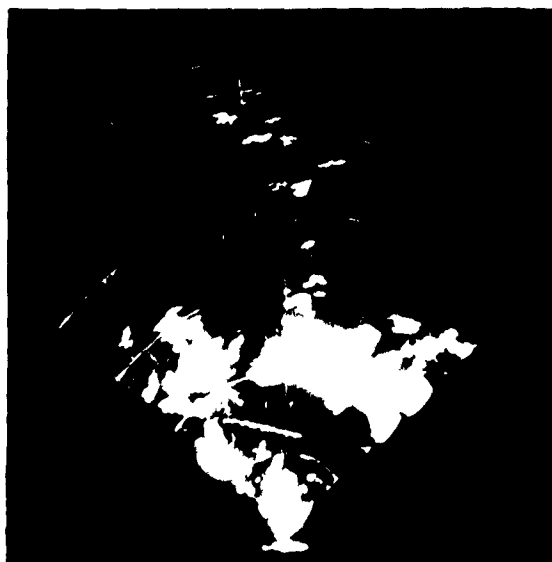
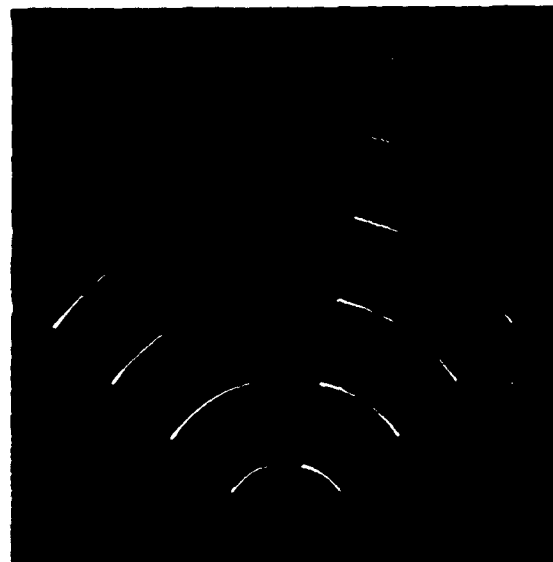
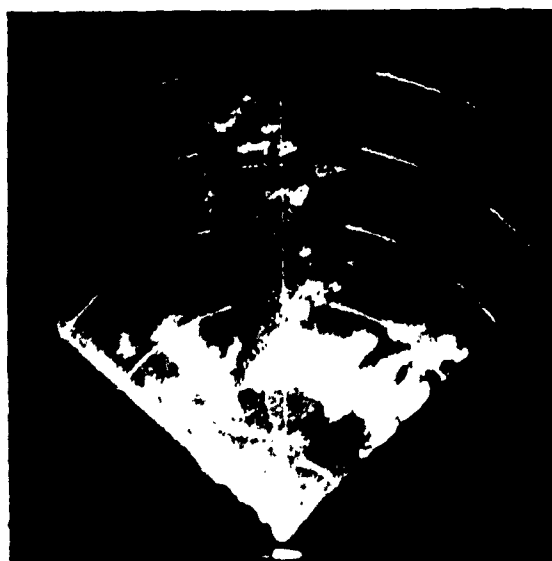
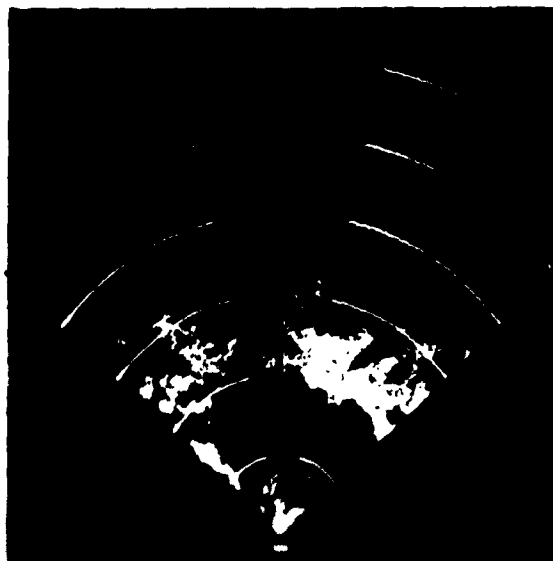
(a) Maximum Σ , no Δ .

(b) Maximum Δ .

(c) Maximum Σ and maximum Δ .

(d) Maximum Δ , Σ gain reduced.

FIG. 25. Comparison of Ground-Test Displays Employing Elevation MRI Circuit in Azimuth With Series Clipper. Note increase in noise in (c) and loss of sensitivity and poor MRI in (d).

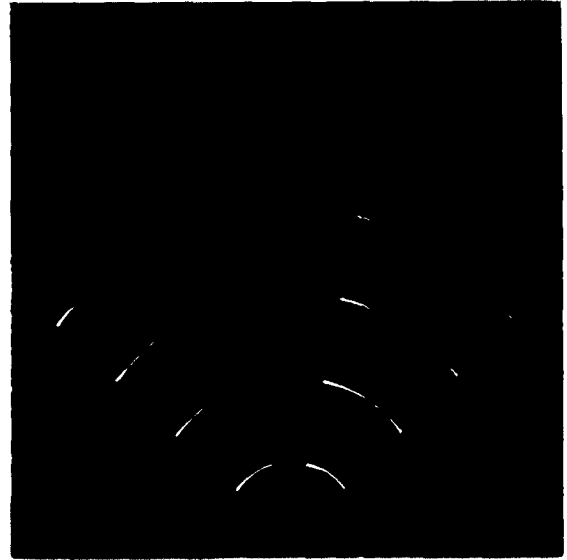
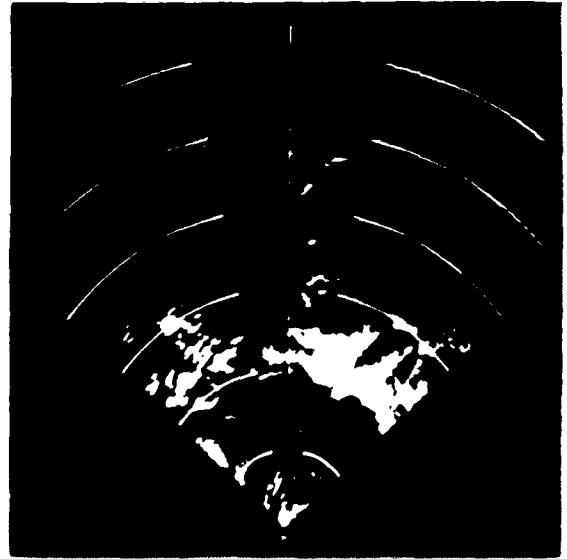
(a) Maximum Σ .

(b) Maximum Δ .

(c) Maximum Σ and maximum Δ .

(d) Maximum Σ and maximum Δ .

FIG. 26. Comparison of Ground-Test Displays Employing MRI Replacement Circuit of Fig. 27. Note slight improvement in sensitivity in (d).

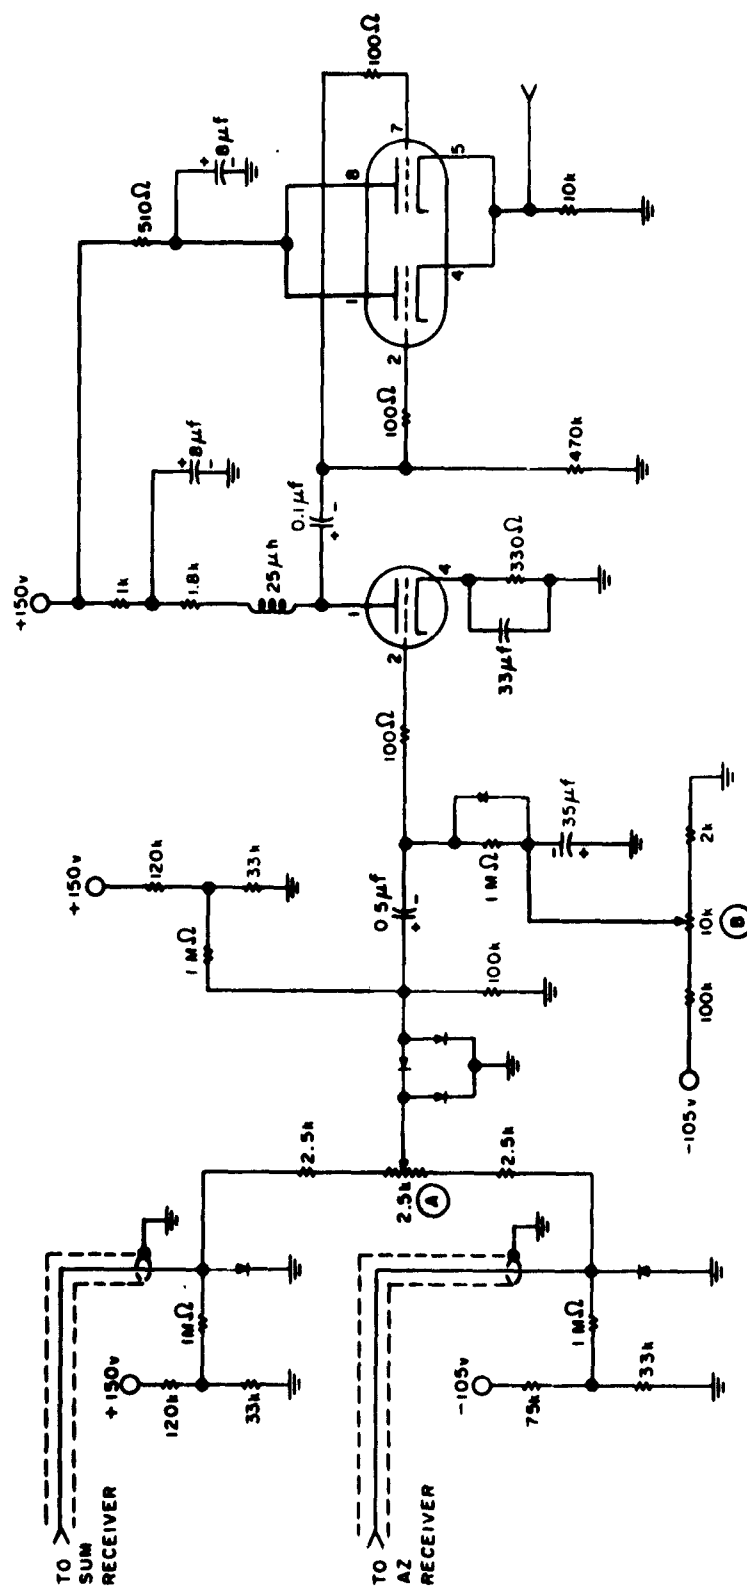
FIG. 27. PRI Replacement Test Circuit.

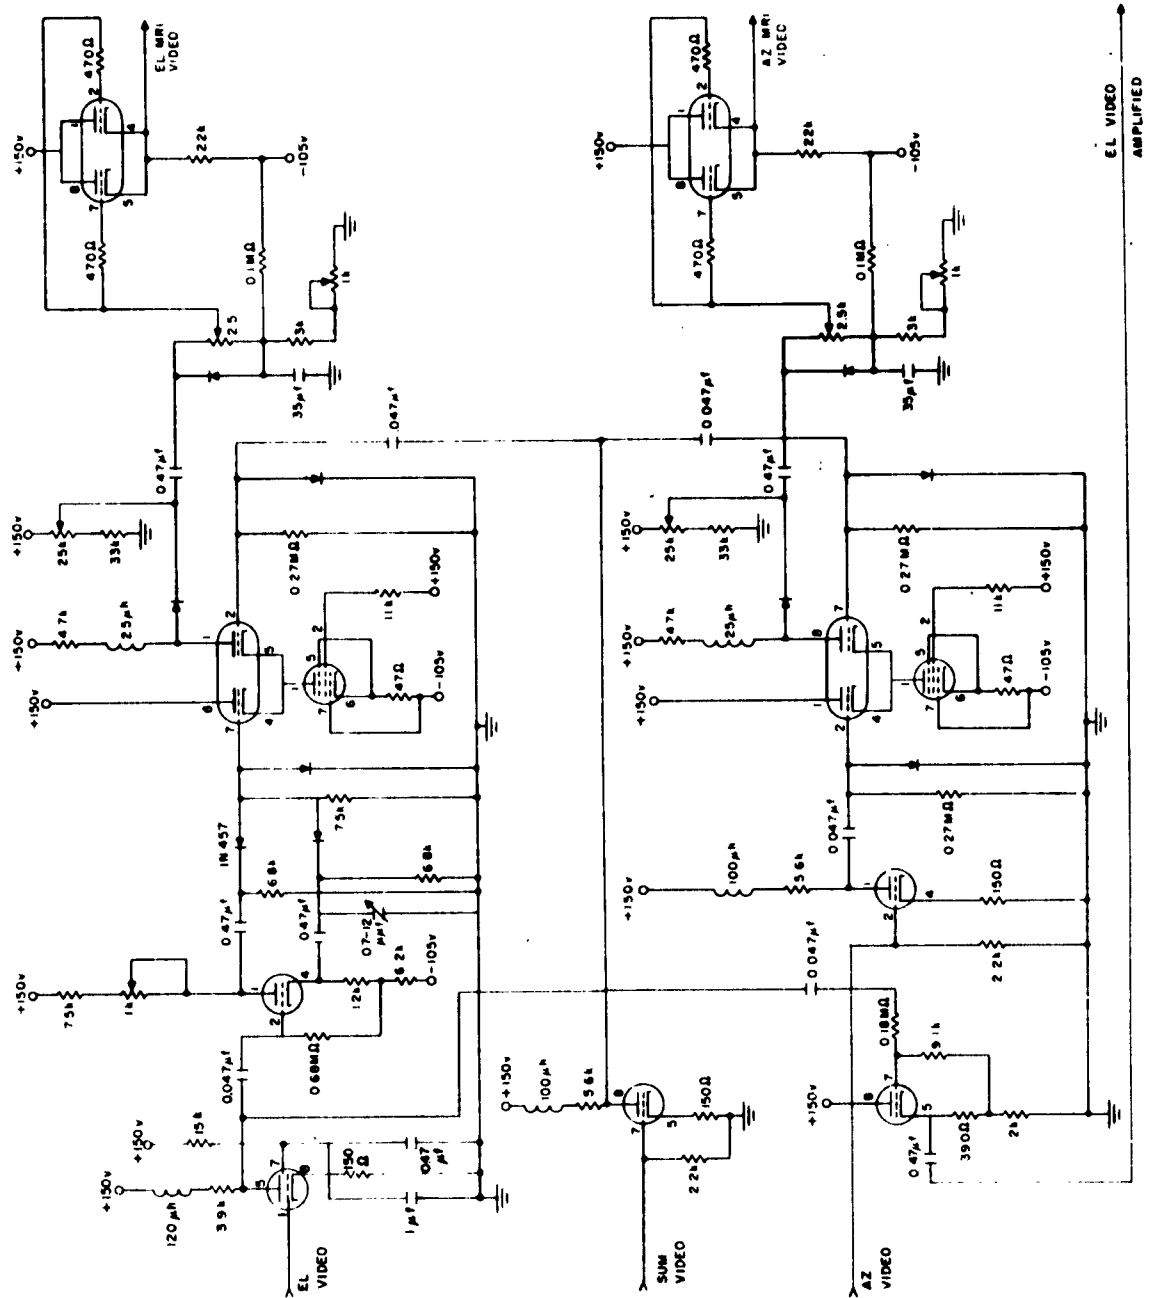
FIG. 28. NAFI-Developed MRI Circuit.

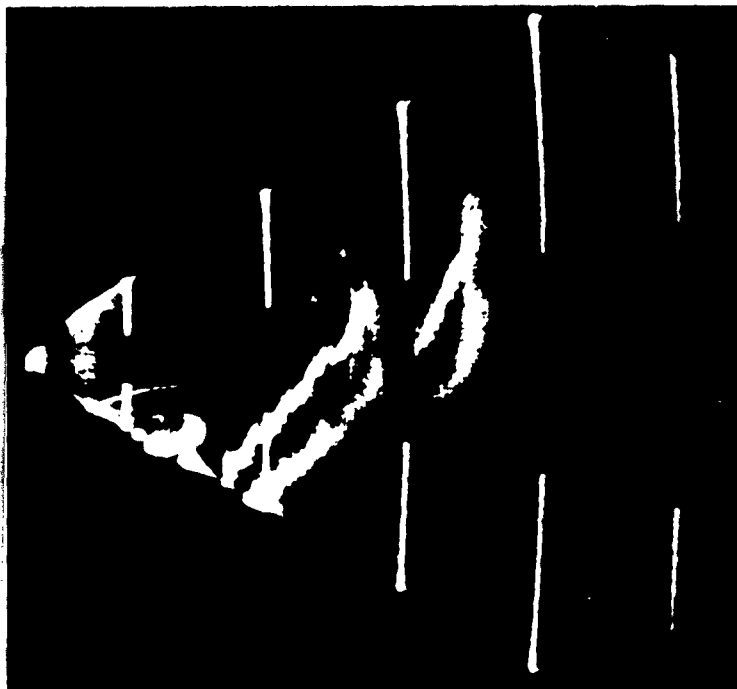
FIG. 33. False Targets, "Shadows".

Two types of false targets appeared when the elevation MRI circuitry was used in the Terrain Clearance mode. These are termed "shadows" and "wings", and examples are shown in Fig. 32b, 33 and 34. Double targets were caused by negative overshoots in the elevation video circuits, and wings were caused by interaction between the sum and elevation difference channels. Figures 35 and 36 show the results when these effects were minimized.

Flt. No.	Date	Comments
		sensitivity and an increase in noise on the indicator in the form of streaks or flashes.
		Maintenance. The cause of the loss of sensitivity could not be determined, since everything appeared to be working normally during ground checks. The indicator noise appeared when the depression axis of the antenna was moved.
13	24 Mar 60	This flight was to check performance in the <u>Terrain Clearance</u> mode (Fig. 31 and 32). Six runs were made on <u>Telescope Peak</u> (11,049 feet) in the <u>Death Valley</u> area with the aircraft flying at 10,000 feet m.s.l. Two types of false targets appeared when using MRI in the <u>Terrain Clearance</u> mode. These are termed "shadows" (double targets) and "wings," examples of which are shown in Fig. 32b, 33, and 34 (discussion on page 25).

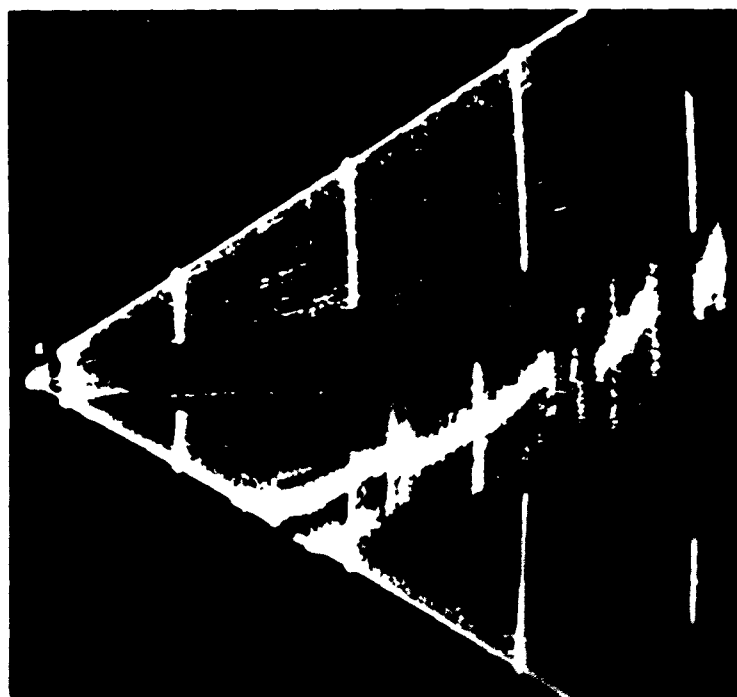
FIG. 34. False Targets, "Wings".

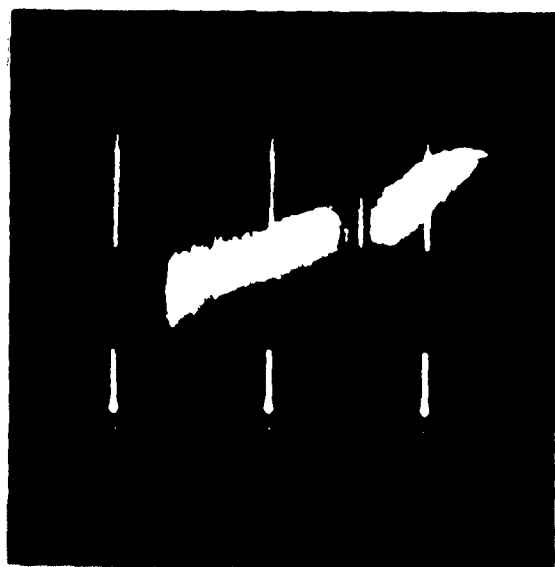
(a) Σ only.

(b) MRI.

(c) Σ only.

(d) MRI.

FIG. 35. Terrain Clearance, E-Scan; Death Valley Area. Five-mile markers; note improvement in false target problem.

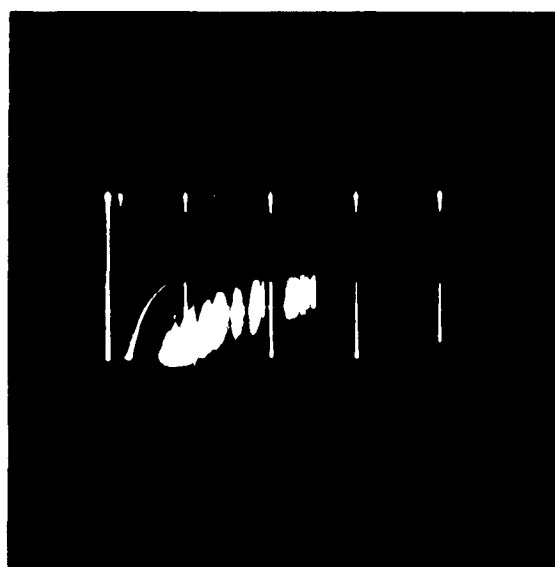
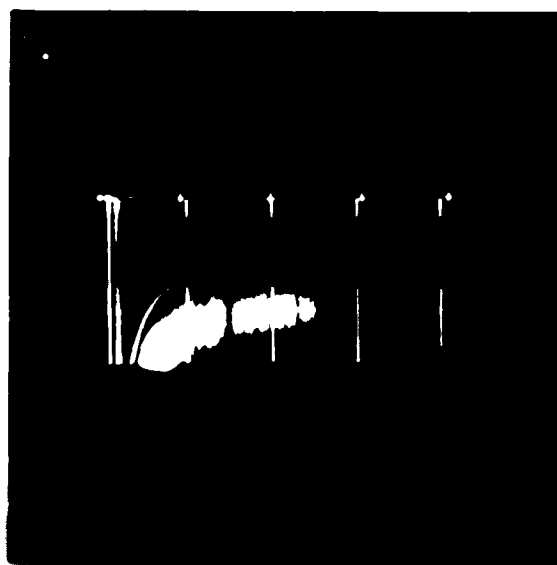
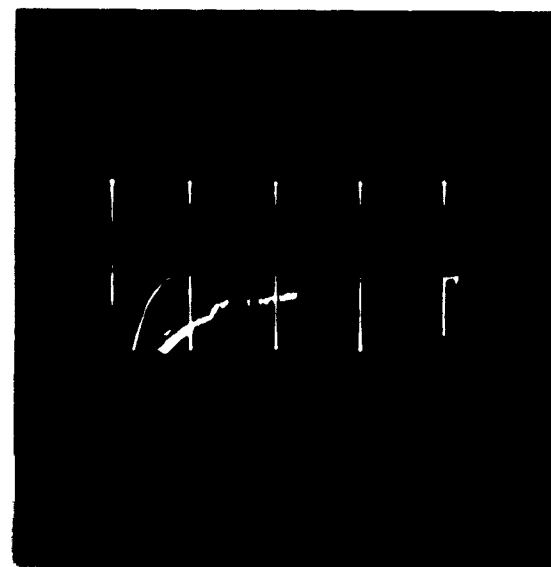
(a) Σ only.

(b) MRI.

(c) Σ only.

(d) MRI.

FIG. 36. Terrain Clearance, E-Scan, Mono Lake Area. Five-mile markers.

-	27 May 60	<p>The scheduled flight was canceled because of a loose propeller blade on the aircraft. Continuous trouble with the aircraft kept it grounded until the flight of 6 July 1960.</p>
20	6 Jul 60	<p>Maintenance. During a ground check of the radar, the 1,000-foot clearance line disappeared. The trouble was traced to an intermittent pulse transformer. The Σ channel 1N78A crystal mixers were replaced with a pair of 1N78Bs to improve sensitivity.</p> <p>SFO. Good radar performance was found to be a function of the adjustment of the clipping level of the MRI unit. The clipping level was extremely difficult to adjust, and drift made it impossible to hold the correct level for a reasonable period. Solid painting to 100 n. mi. and hard targets to 120 n. mi. were observed while the clipping level was in correct adjustment. The MRI looked improved in both the <u>Terrain Clearance</u> (Fig. 36) and <u>Mapping</u> modes.</p>

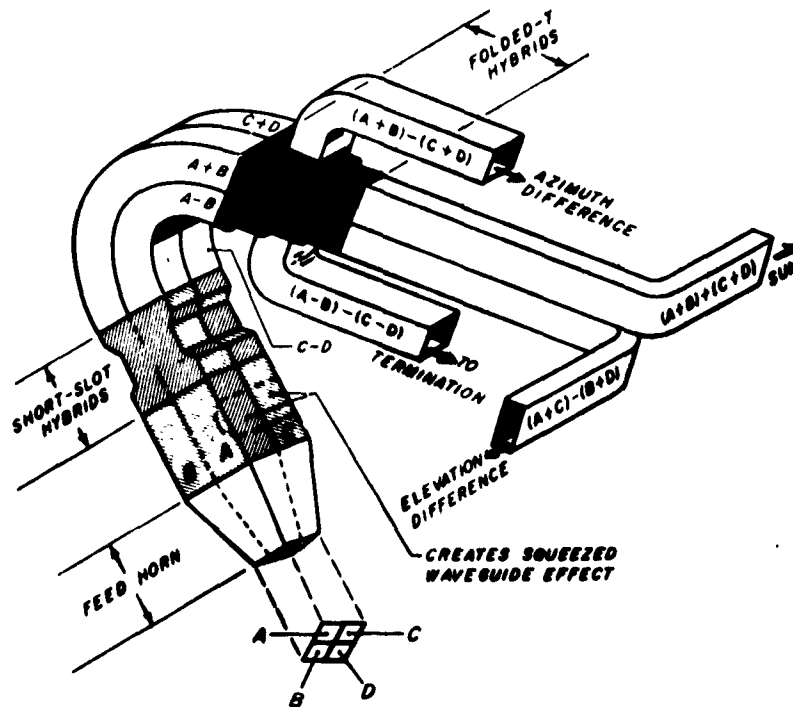
ANTENNA SECTION. To restrict losses in signal strength caused by waveguide attenuation and multiple rotary joints, all microwave components were physically mounted to the rear of the reflector on the elevation axis of the antenna (see Fig. 1). This assembly consists of the transmit—receive (T-R) duplexer, the directional coupler, the klystron local oscillator, the balanced crystal mixers, and four identical pre-IF amplifiers having a 20-db gain.

Through the waveguide transmission lines, these three signals are sent to the waveguide assembly. A part of this assembly consists of the four balanced crystal mixers, where three of the modified signals are independently heterodyned with the local oscillator frequency to produce three IF signals. The mixer crystals are protected during the time the transmitter is pulsed by T-R tube assemblies on the waveguide transmission lines. The fourth mixer receives a sample of the magnetron power, extracted for the AFC circuit by the directional coupler, which is used to maintain the constant 60-Mc difference in frequency between the output of the magnetron and that of the local oscillator.

The heterodyned Σ , azimuth Δ , elevation Δ , and AFC signals are amplified by four pre-IF amplifiers that are part of the assembly mounted on the back of the radar antenna. The four amplifiers are identical, and have a gain characteristic of 10 db, a bandwidth of 18 Mc, and a noise figure of 2 db or less.

FIG. 40. Comparator and Four-Horn Feed Assembly.

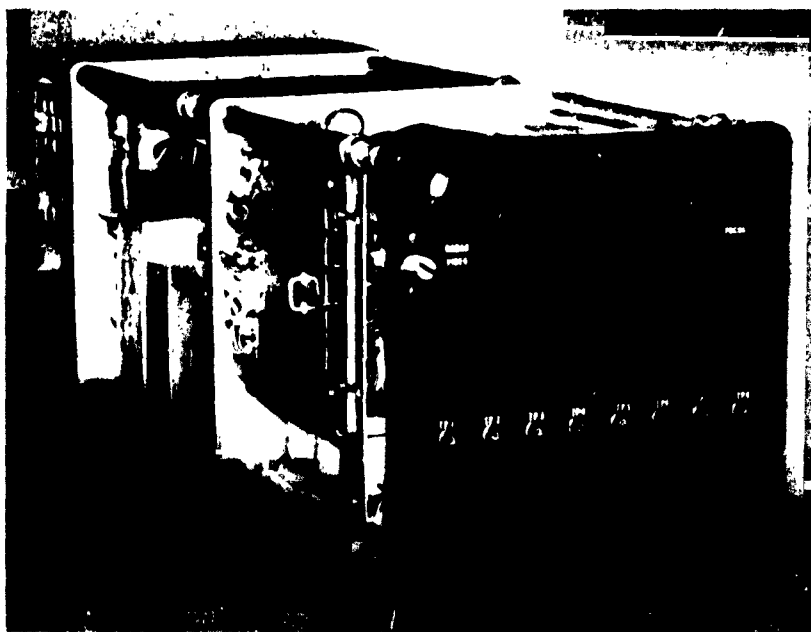
RECORDING STORAGE UNIT. The RSU (Fig. 44) stores the radar presentations when the Single Scan mode is used. This permits the navigator to re-view a stored presentation while radar silence is being maintained or while the pilot is using the Terrain Clearance mode. In this mode, use or the SS ACTION button turns the transmitter-receiver on during one scan of the antenna. The terrain-clearance presentation is disrupted momentarily when the antenna reverts to the Search mode for one scan,

FIG. 44. Recording Storage Unit.

but is resumed in about four seconds. In the same length of time, the new picture stored in the RSU will be shown on the navigator's indicator. The recorded picture can be rewritten on the navigator's indicator during the next 5- to 10-minute interval. The length of time the picture is retained by the RSU depends on the number of times it is rewritten on the navigator's indicator.

The four modes of operation of the RSU are Erase, Prime, Write, and Read. The first three of these accomplish the recording function, and Read is considered the normal mode for the unit. These modes are controlled by relays in the programmer unit of the RSU.
